# ***Dynamic loads in ESP and production tubing, and how to avoid subsequent damage***

EBN, 10.12.2025

Matthias Möller, **geoTKP** Consulting

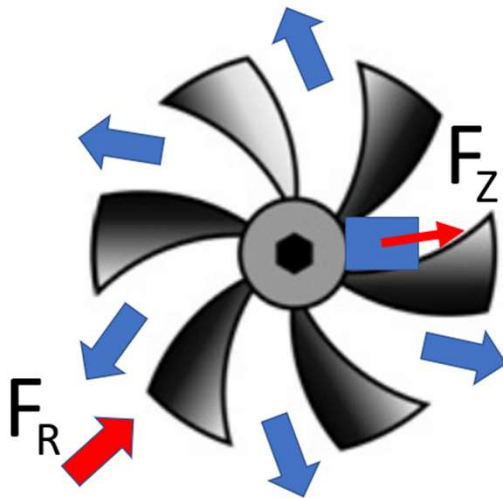
- pump sucks in a piece of stabilizer that broke off during installation
- the resulting imbalance creates extreme vibration and wears the rotors on one side

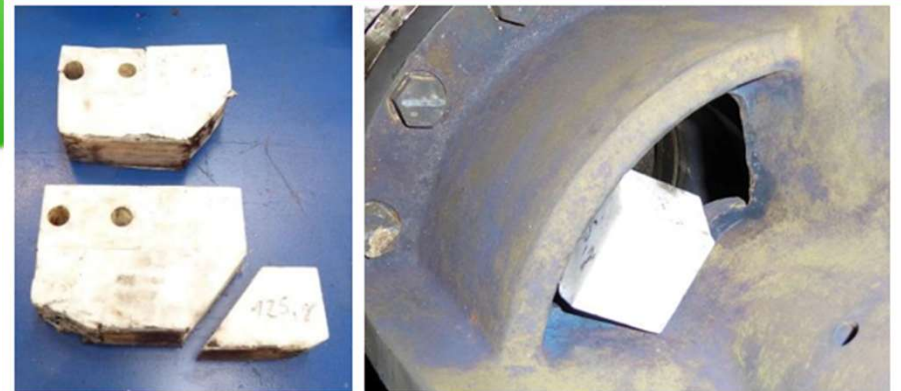
picture 30: reproduced Teflon piece fits through intake

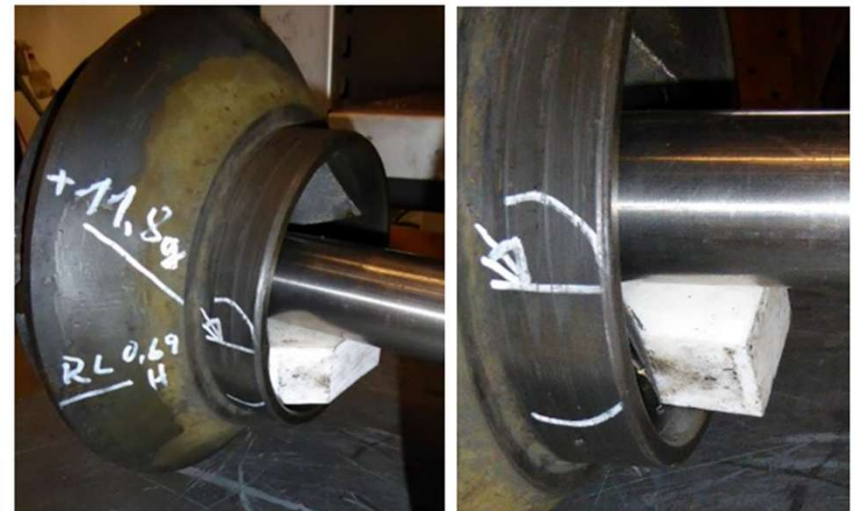
picture 31: reproduced Teflon piece fits into impeller shroud

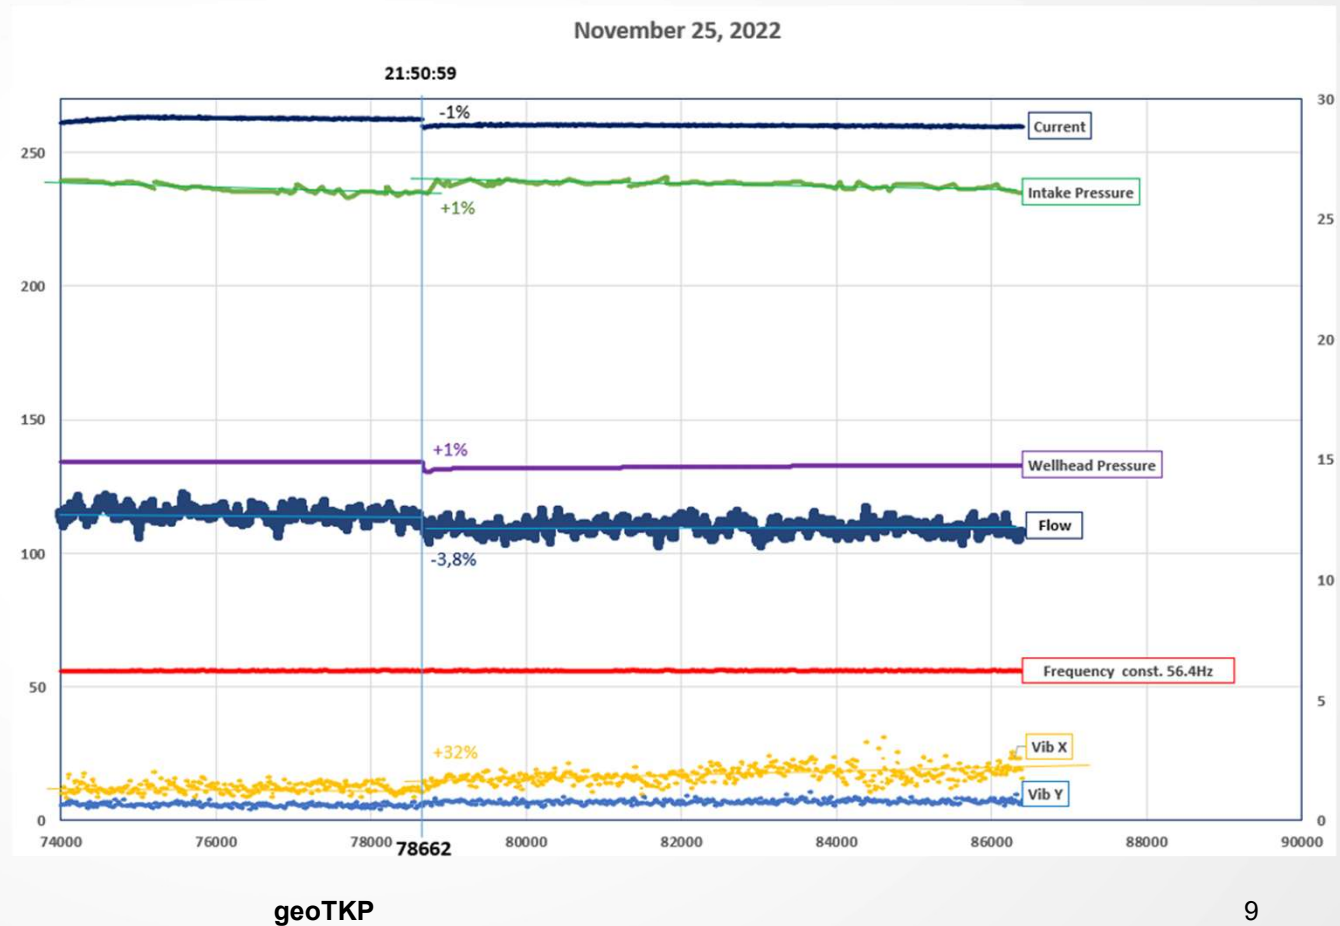
- constant RPM
- decrease in flow (-3,8%)
- decrease of efficiency
- drastic increase of vibration (+32%)

partially plugged pump

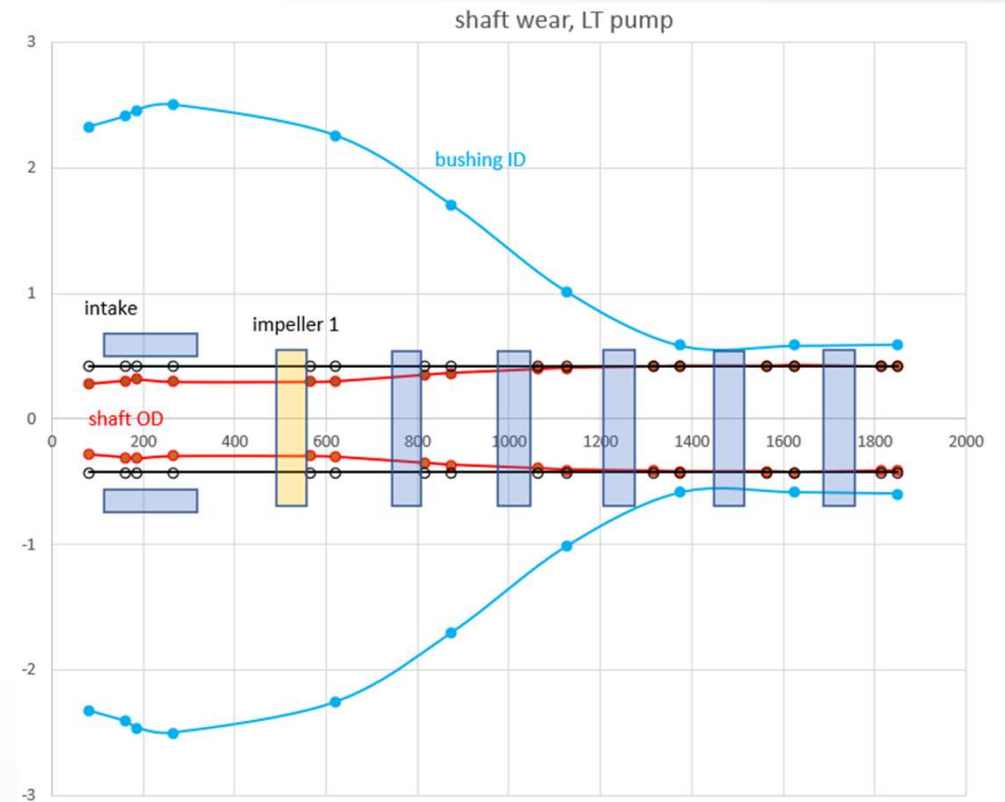
- Concentric wear of the stationary bearings: maximum around the first impeller
- first impeller with significant eccentric wear

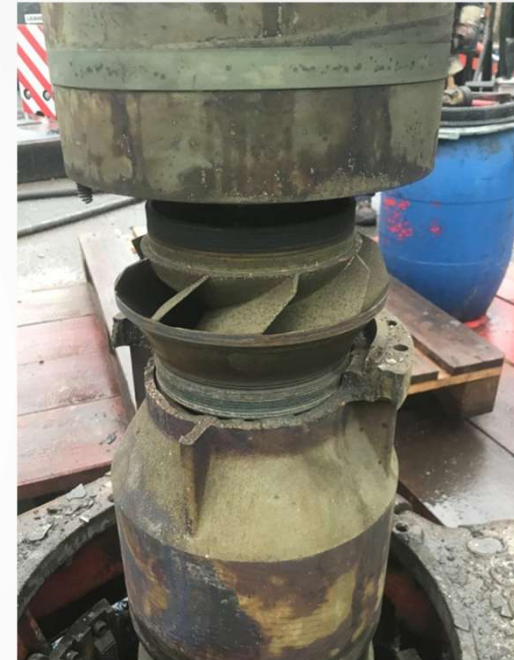
Bearing damages and fatigue fractures due to insufficient stabilisation

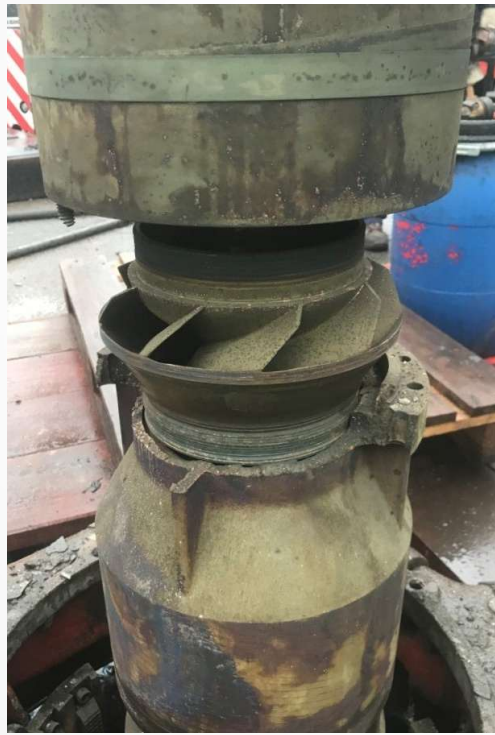
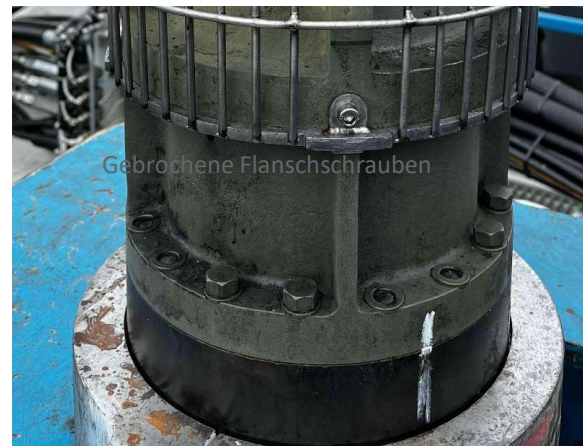
Lost flange bolts

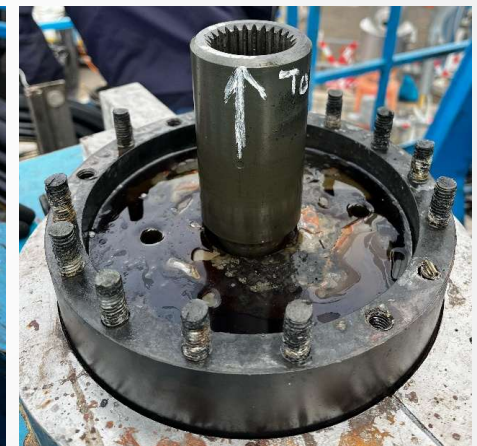
Broken flange bolts (pump intake)

**Cause:**

Low frequency oscillation of the production tubing

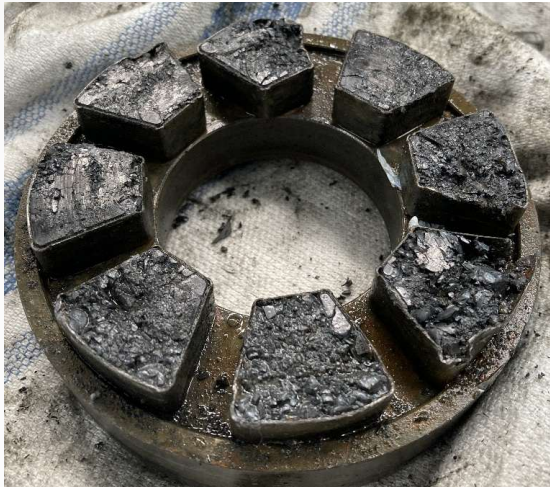
Shattered thrust bearing caused by pressure pulses

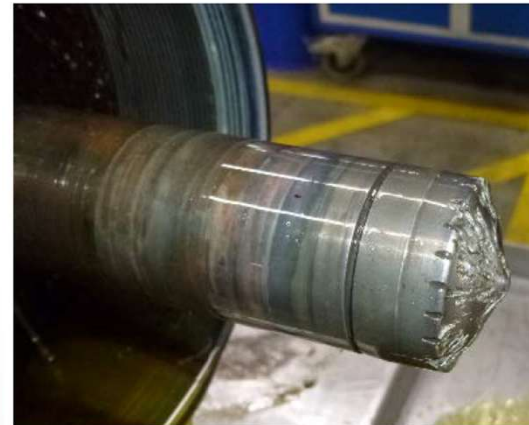
broken motor shaft (torsional oscillation in resonance with power supply)

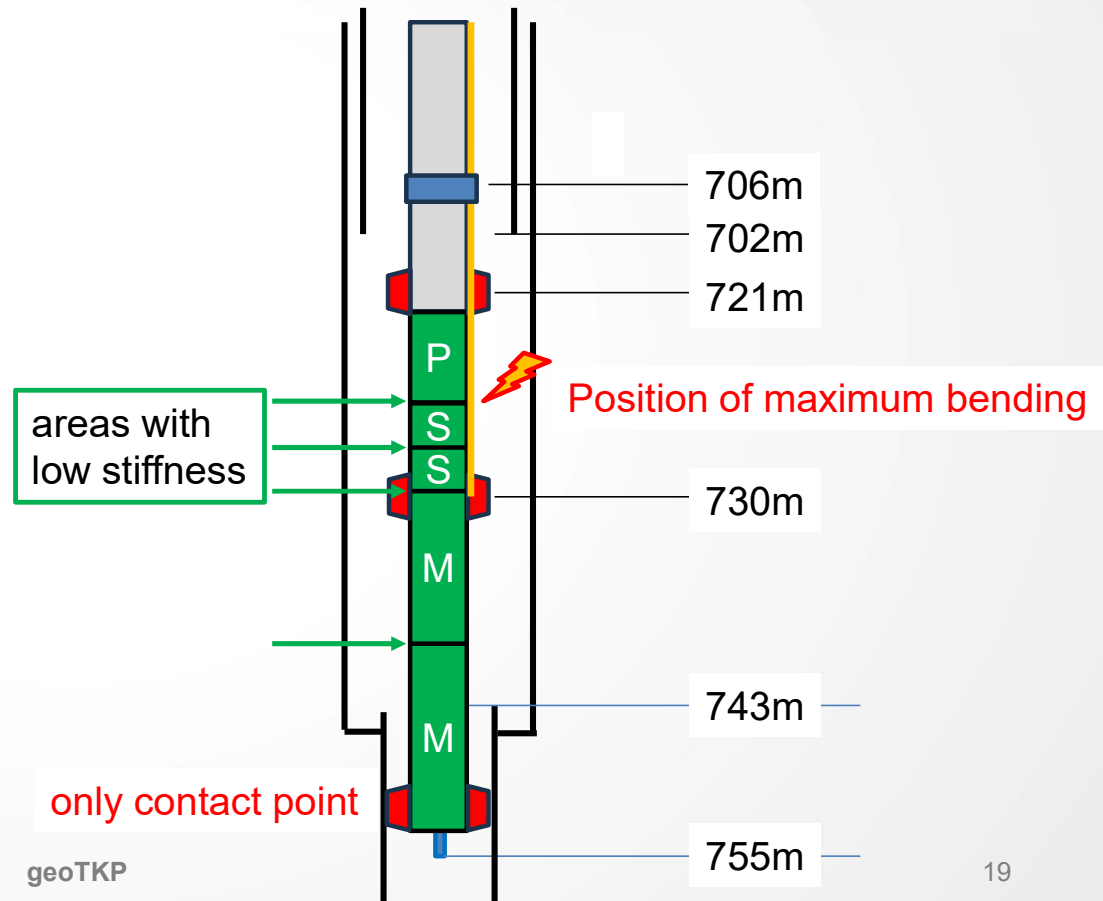
- No stabilisation of ESP against lateral movement of the heavy and stiff production tubing
- Excessive (dynamic) bending in the areas with bearings will lead to excessive bearing loads
