# ***Dynamic loads in ESP and production tubing, and how to avoid subsequent damage***

EBN, 10.12.2025

Matthias Möller, **geoTKP** Consulting

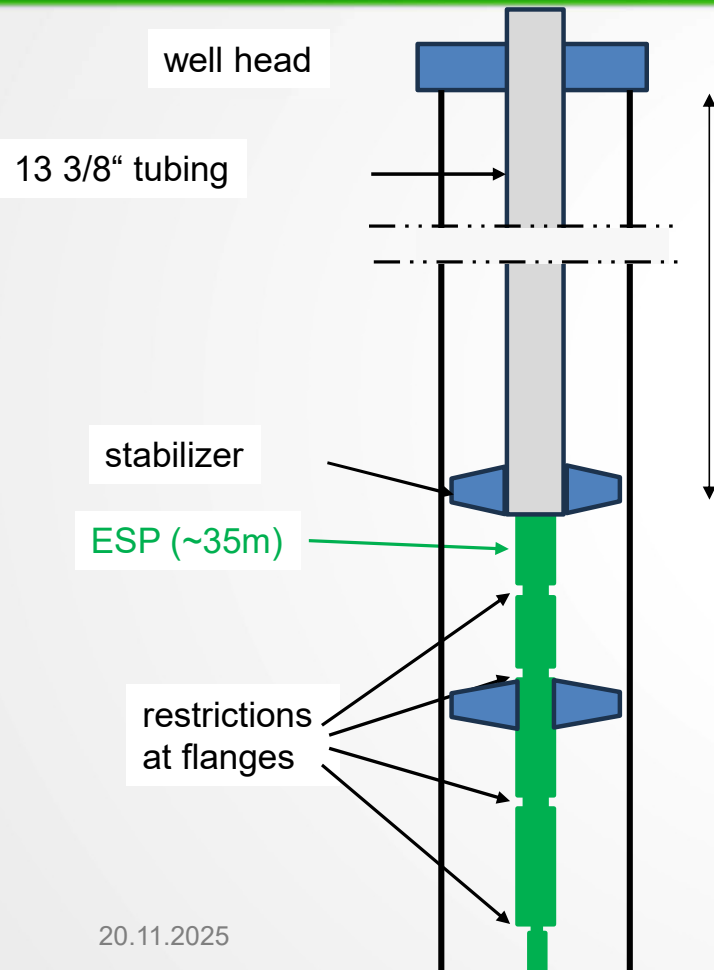
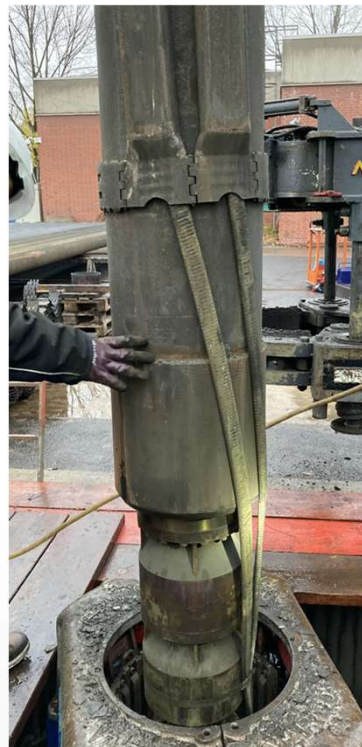
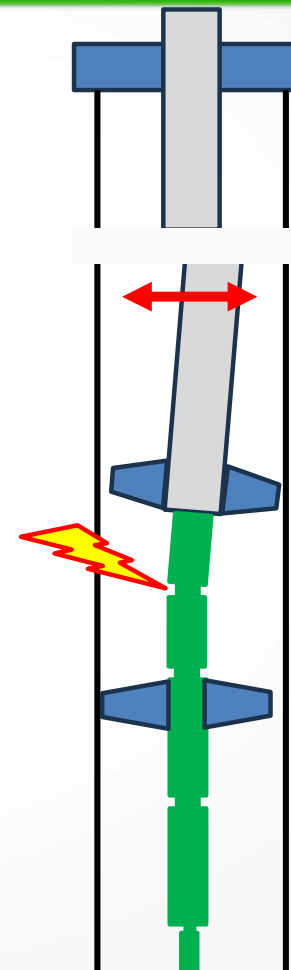
low frequency lateral vibration of the tubing due to vertical installation and high flow rates

oscillating bending loads in the most flexible section of the ESP (e.g pump intake)

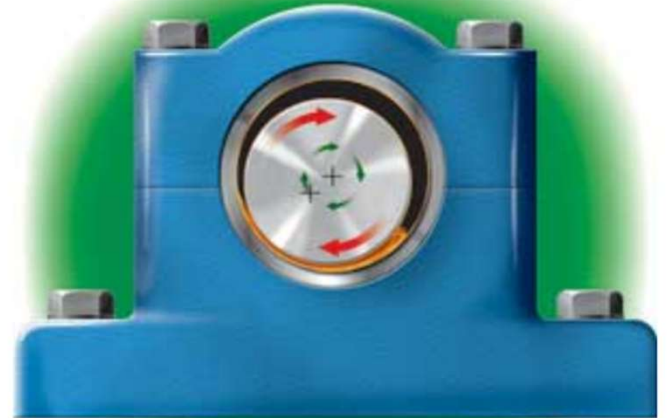
- the oil film in (up to 15) motor bearings forms a wedge, which rotates around the shaft (with half rotation frequency) due to insufficient static load in the bearing.

### Half-frequency whirl

- this phenomena is depending on the temperature /oil viscosity

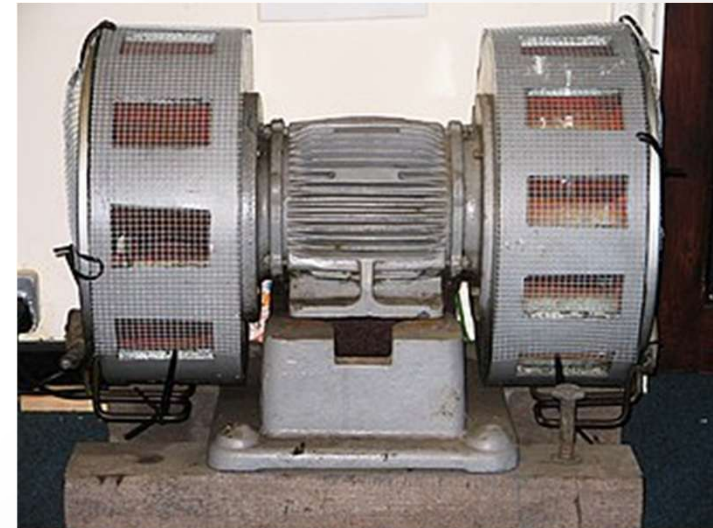
- With equal numbers of vanes in the impellers and diffusers, high frequency pressure pulses can be created in the fluid ( $n = \text{rpm} \times \text{number of vanes}$ , e.g. 400Hz)
- When these pressure pulses are in **resonance** with the production tubing or fluid column, extreme vibrations can be created and transmitted to the well head, where they will be clearly audible
- **Acoustic measurements** at the wellhead !!!

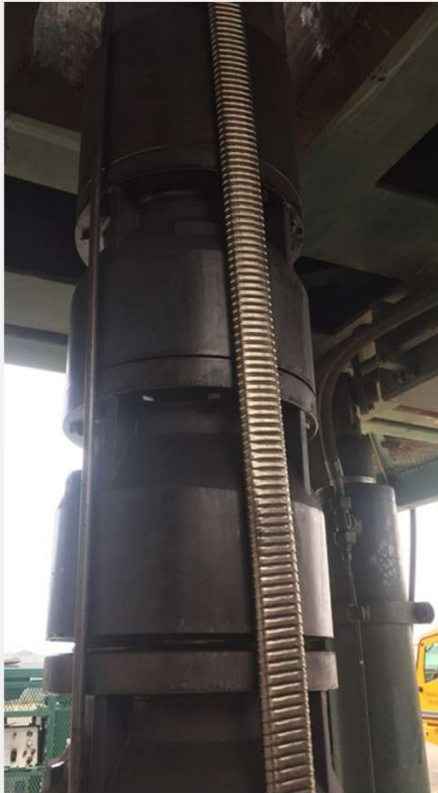
Shattered thrust bearing caused by pressure pulses

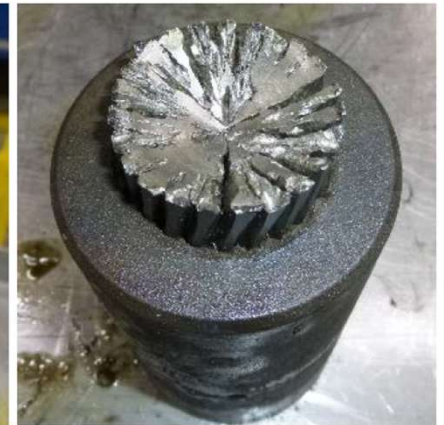
broken motor shaft (torsional oscillation in resonance with power supply)
