Anticipating Drilling Hazards

by Sharing

Geo-Drilling Events Information Nationwide

EBN B.V. The Netherlands

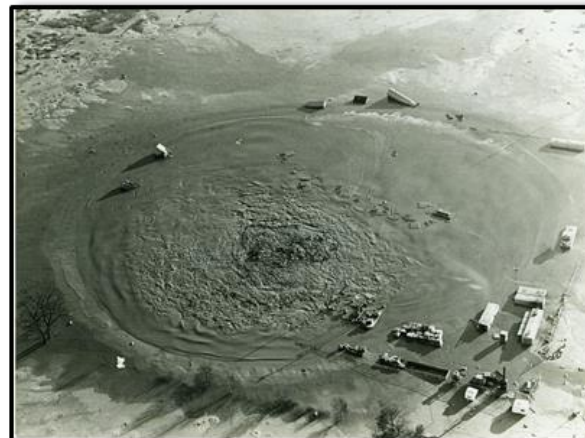
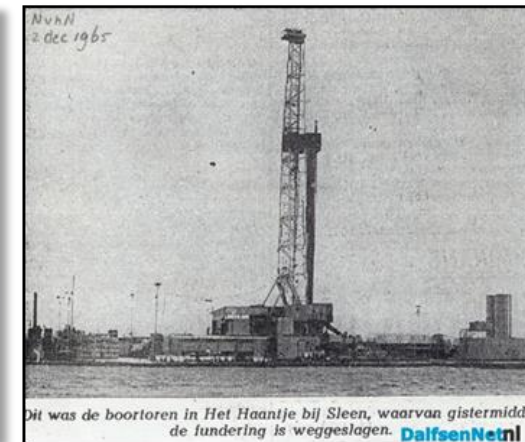
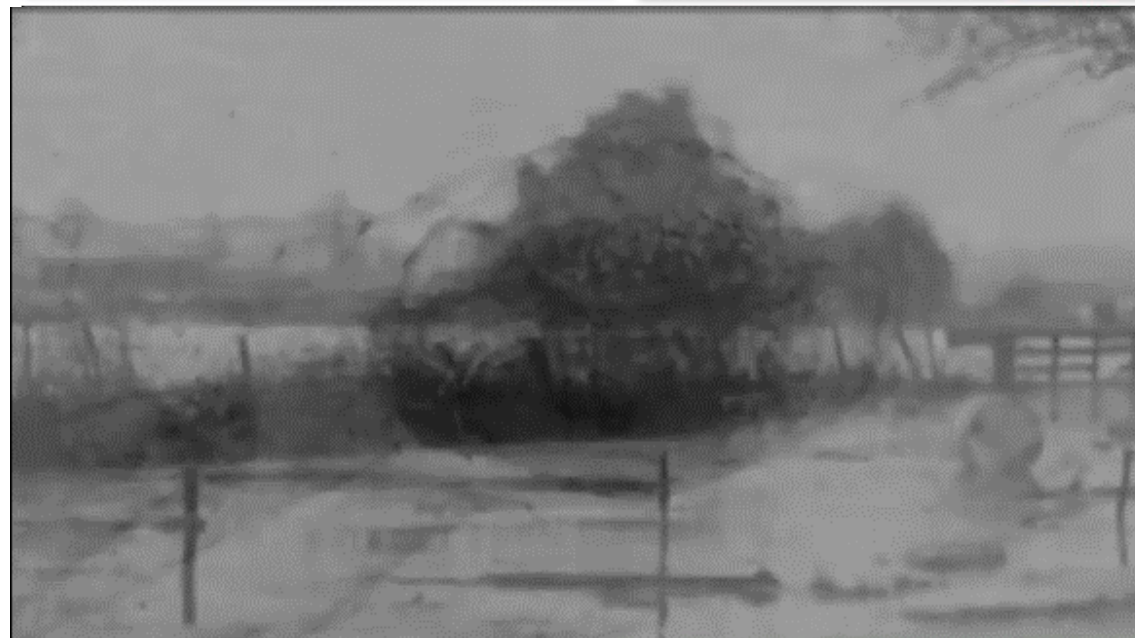
- Blow-out in Het Haantje 1965
- Unexpected over-pressured gas accumulation encountered at 1950m
- **Gas kick** was not contained and gas mobilized upwards
- Once pressure exceeded fracture strength of mechanically weaker shallow sediments gas escaped
- No injuries but the drilling rig and portacabins sunk into the ground

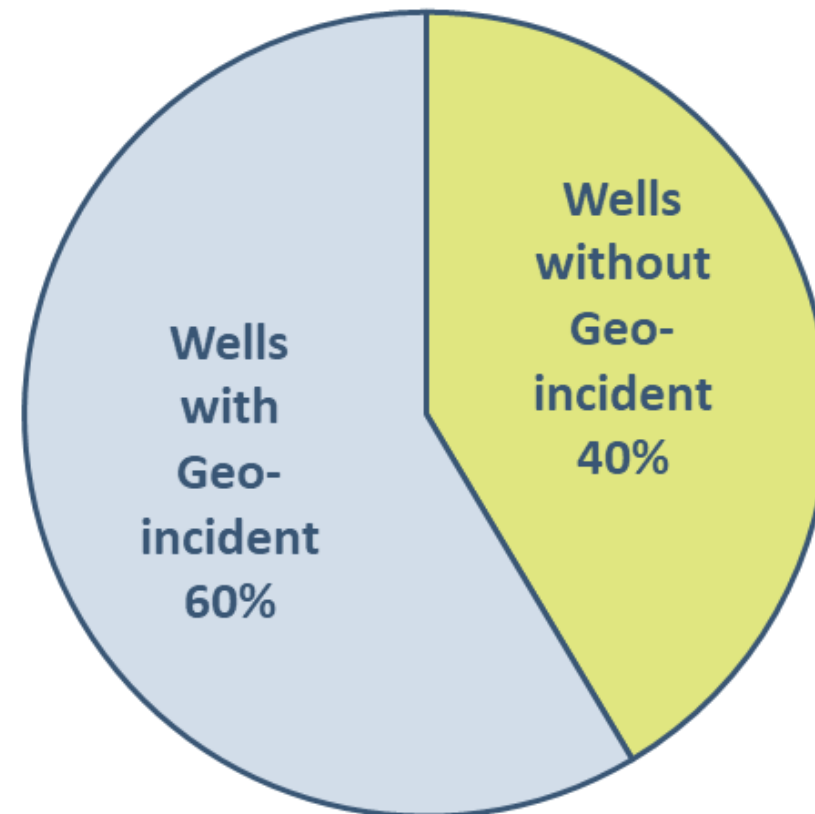
Results To Date*

- Number of boreholes analyzed 1000
- Boreholes with Geo-Events 600
- Number of Geo-Events 1170
- Wells with Insufficient data 80

*statistics as per Sep 2019

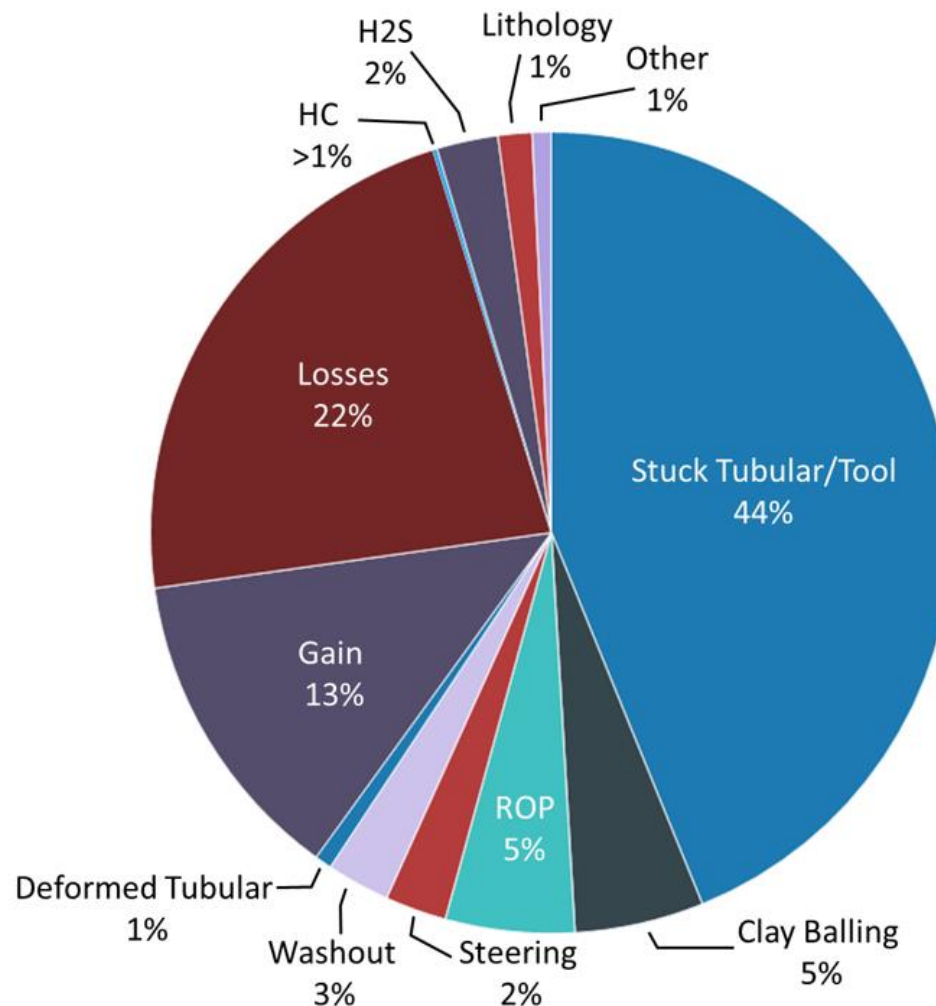
Drilling Events = facts

Event types	1	Stuck Tubular/Tool	514
	2	Clay Balling	61
	3	ROP	61
	4	Gain	150
	5	Losses	263
	6	Lithology	16
	7	HC	2
	8	H2S	29
	9	Deformed Tubular	8
	10	Washout	30
	11	Steering	29
	12	Other	9
		Total events	1172

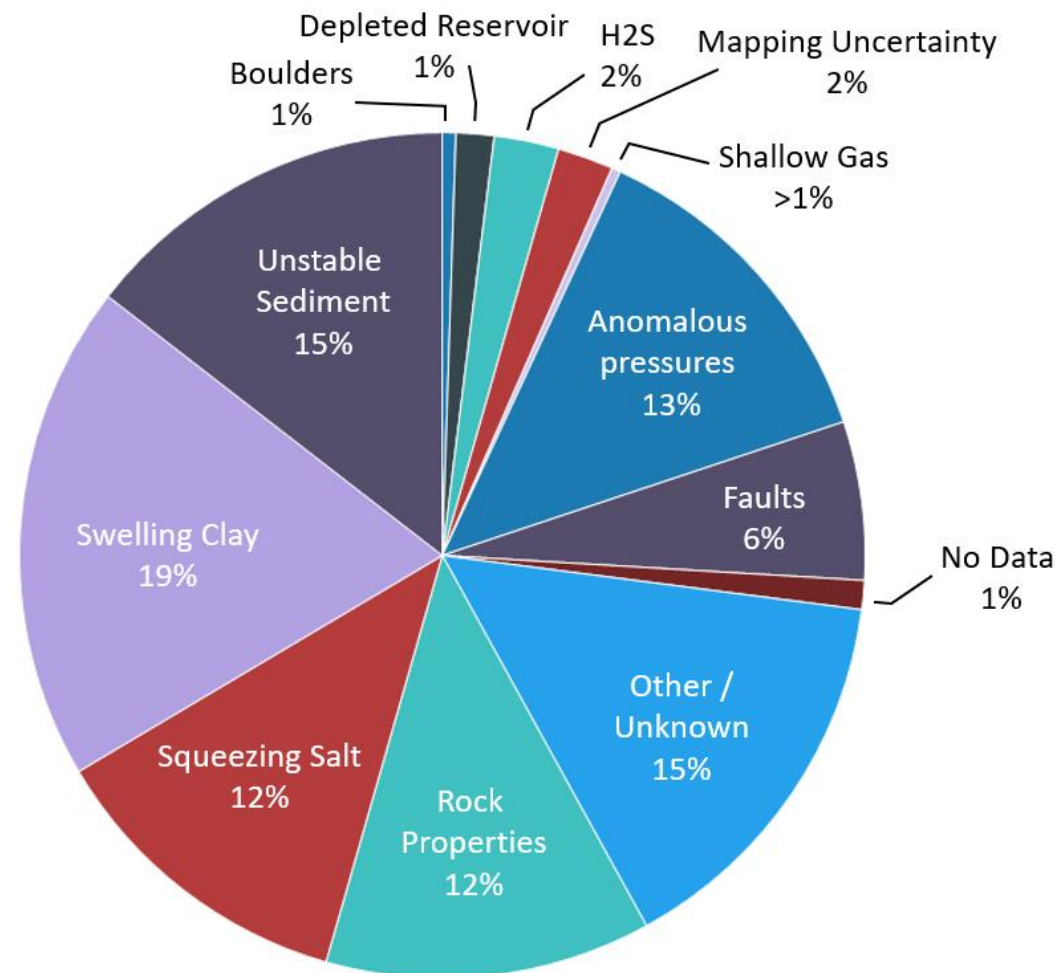
Geo hazards = geo interpretation

rocks	Faults	71
	Swelling Clay	223
	Squeezing Salt	141
	Unstable Sediment	170
	Boulders	6
	Rock Properties	146
fluids	Depleted Reservoir	17
	Shallow Gas	4
	<u>Anomalous Pressures</u>	152
	H2S	29
other	Mapping Uncertainty	25
	Other / Unknown	175
	No Data	13
Total		1172

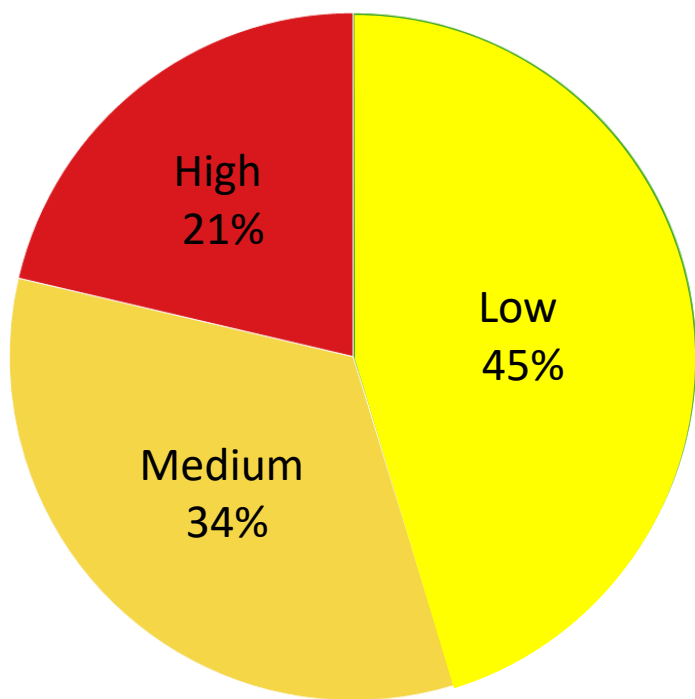
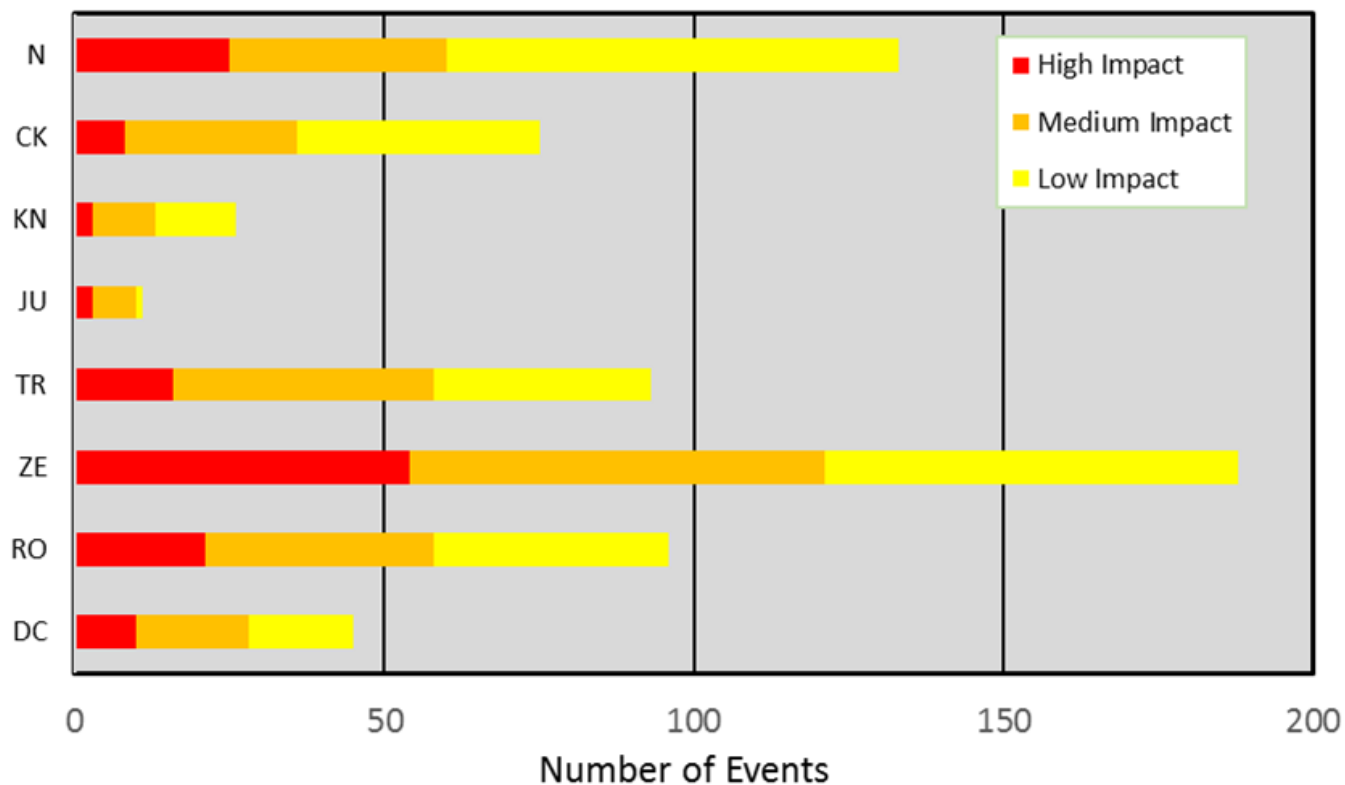
Incident severity

Severity of incident:

Semi-quantitative classification based on NPT and (potential) impact.

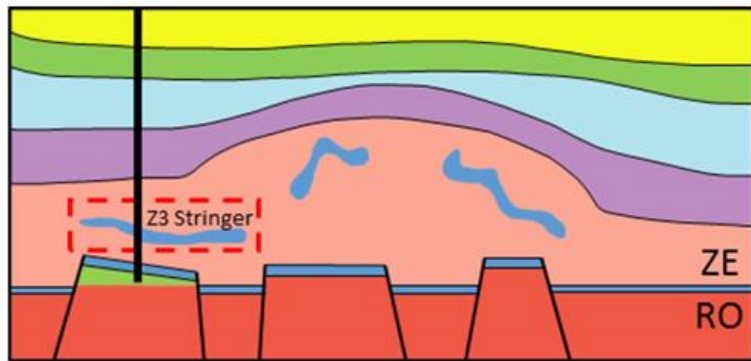
Subsalt faulting initiates halokinesis which will trigger differential loading

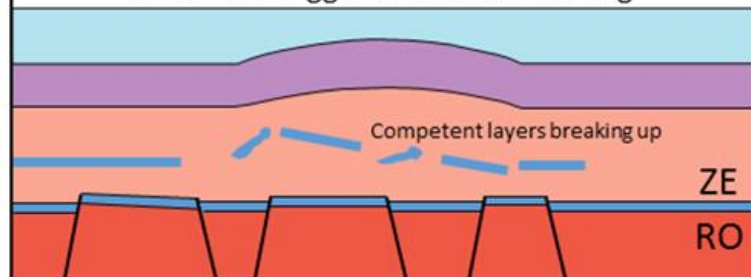
Zechstein deposition

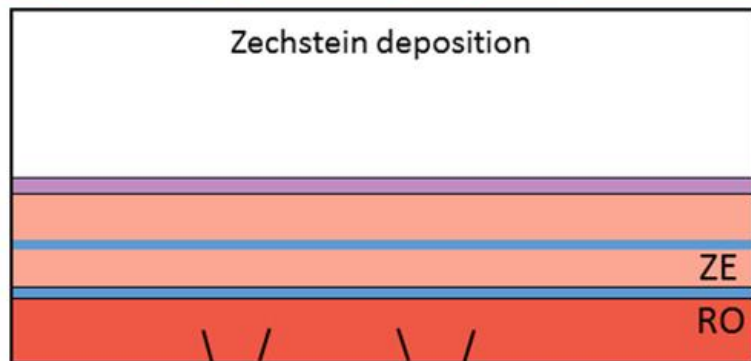
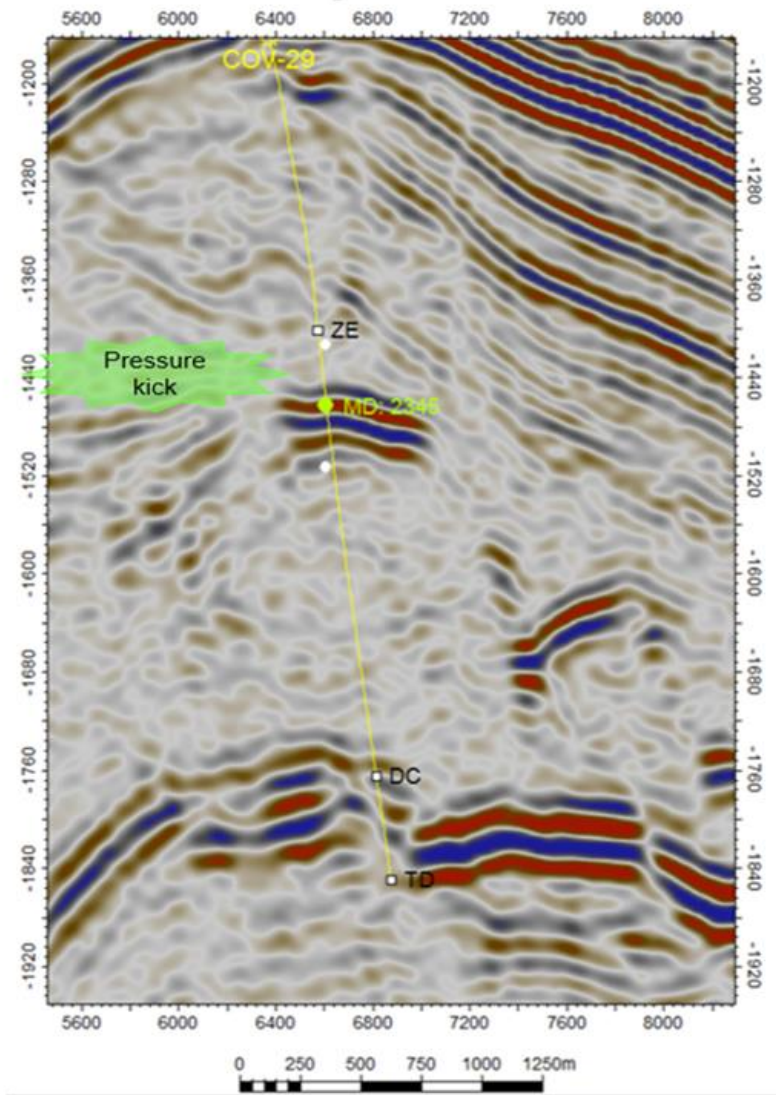
Intra salt geobodies often contain high overpressures !!
